AD REPORT NO. R-1131
DATE: 12 SEPT. 1974

HOT VACUUM CREEP FORMING OF SCALE SHUTTLE
EXTERNAL TANK DOME CAPS

FINAL TECHNICAL REPORT
CONTRACT NO. NAS8-30664

AEROSTRUCTURES DIVISION
AVCO CORPORATION
P.O. BOX 210
NASHVILLE, TENN. 37202

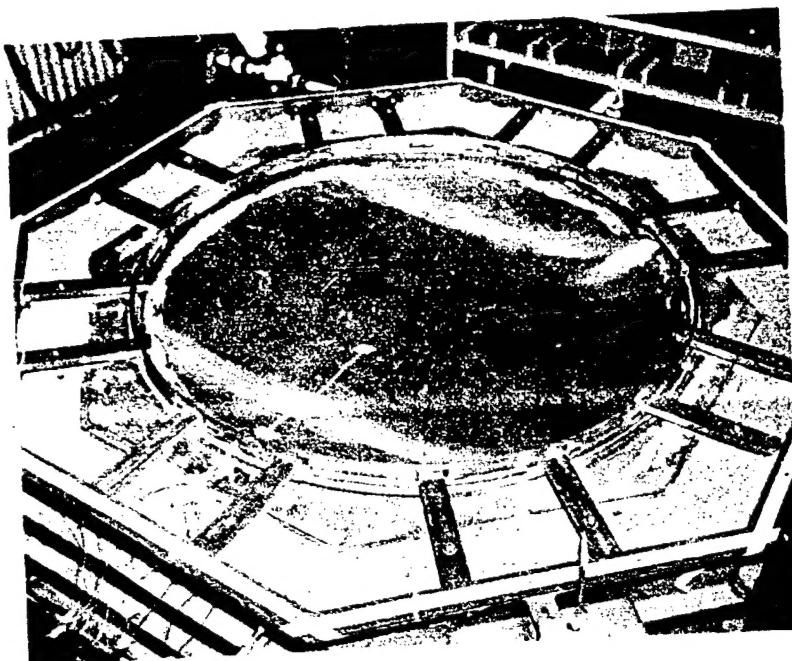
FIGURE 24.

Task DD forming cycle ran with reduced clamping torque (18 ft./lbs.) to allow a limited amount of material movement into the contour. Figure 24 shows Task DD after forming. Buckling occurred at the ring in the weld area.
